# PUBLIC ROADS

A JOURNAL OF HIGHWAY RESEARCH

VOL. 15, NO. 1

MARCH 1934

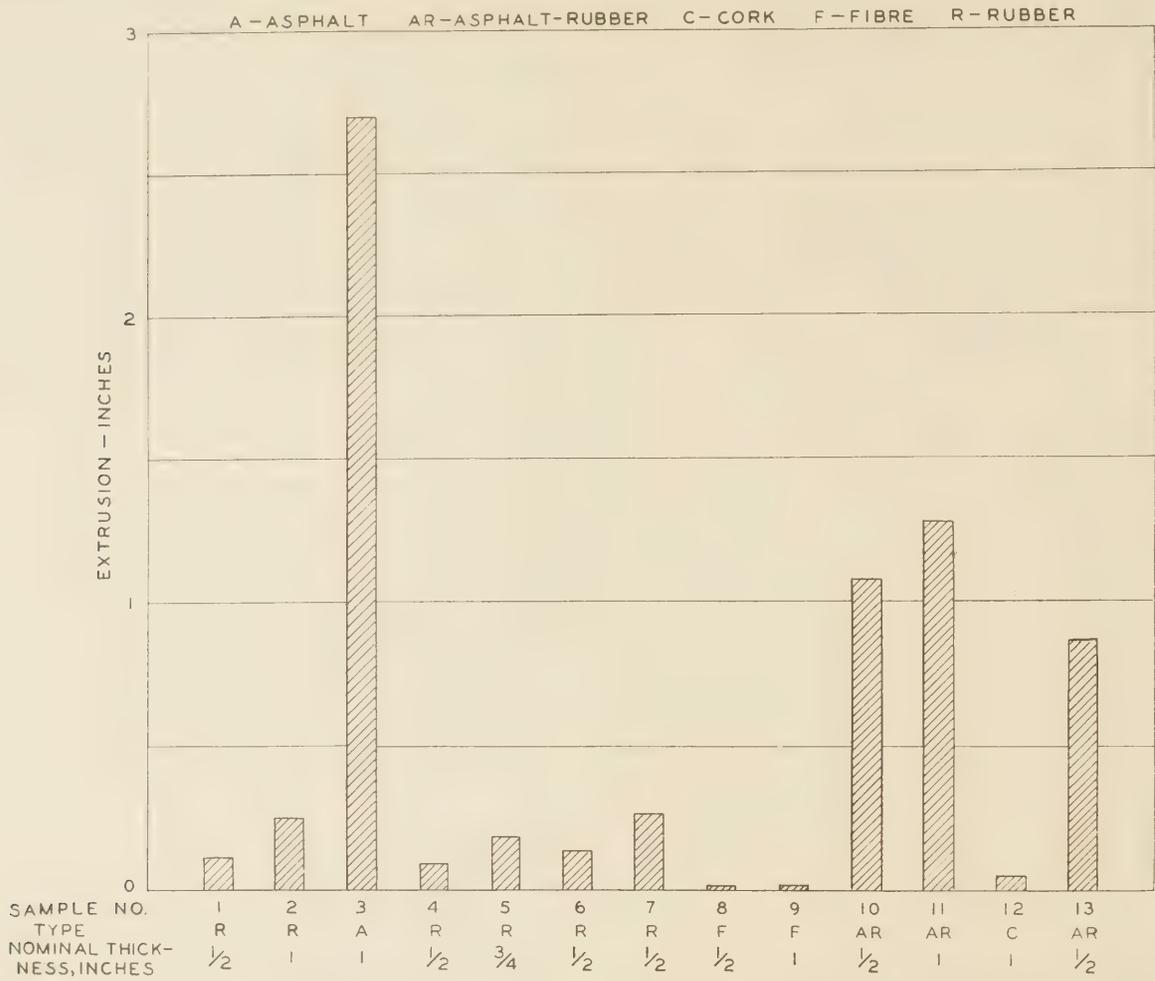
FIGURE 7.—EXTRUSION OF SPECIMENS WHEN COMPRESSED TO ONE HALF THE ORIGINAL THICKNESS AND WHILE RESTRAINED ON THREE EDGES.

The results of the extrusion tests in figure 7 show the asphaltic and asphalt-rubber fillers to have the greatest extrusion. The sponge-rubber fillers showed extrusions of from one tenth to one quarter of an inch. The cork and fiber fillers had practically no extrusion. The cork, fiber, and most of the sponge-rubber fillers had no measurable permanent extrusion, the extruded material returning to its original position upon release of pressure. Samples 6 and 7 showed some permanent extrusion but this did not exceed 0.1 inch. The asphaltic and asphalt-rubber fillers had practically no recovery of the extruded material. Figure 8 shows a sample of asphaltic filler after the test. The extrusion on the left was permitted by a slight movement of the upper plate during the test.

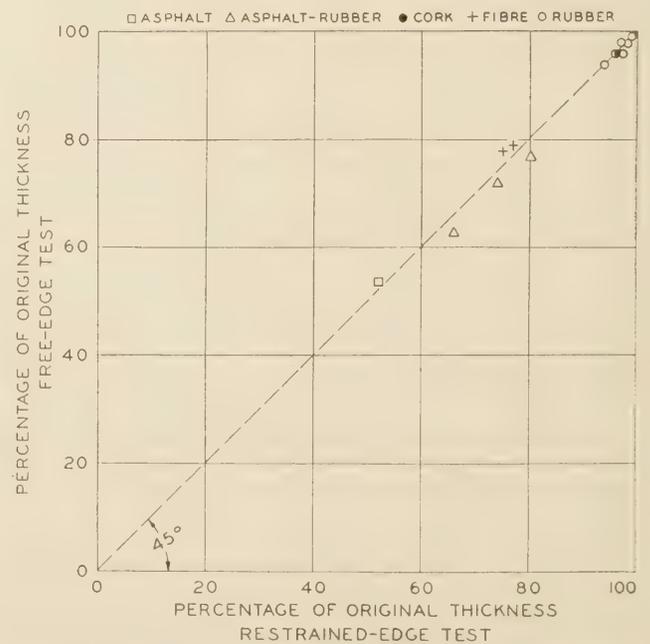
FIGURE 9.—RELATION BETWEEN RECOVERY OF MATERIALS AFTER THE FREE-EDGE AND THE RESTRAINED-EDGE TESTS.

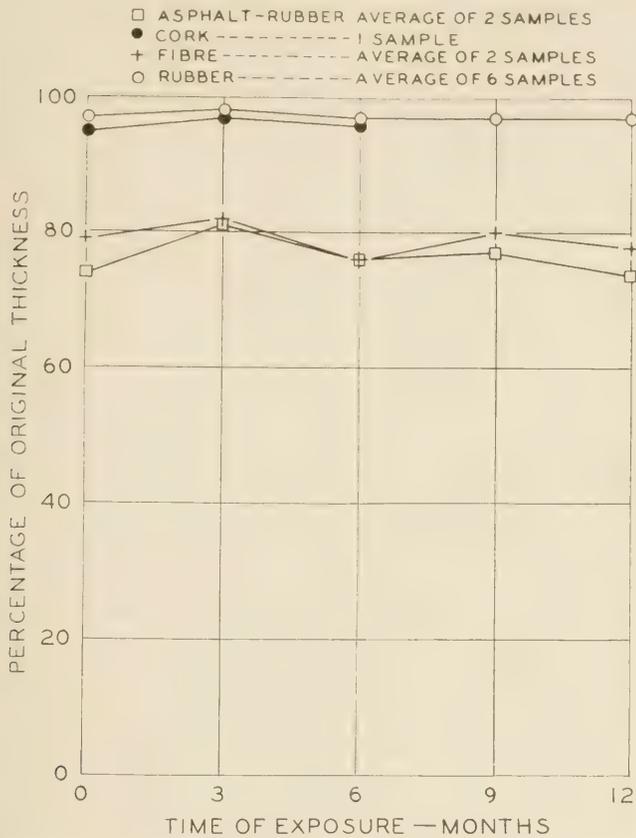
FIGURE 10.—EFFECT OF WEATHERING ON RECOVERY OF SPECIMENS. SAMPLES WERE EXPOSED FOR VARIOUS PERIODS, THEN COMPRESSED MOMENTARILY TO ONE HALF THE ORIGINAL THICKNESS THREE TIMES AT INTERVALS OF 1 HOUR AND RECOVERY MEASURED AFTER A 24-HOUR REST PERIOD.

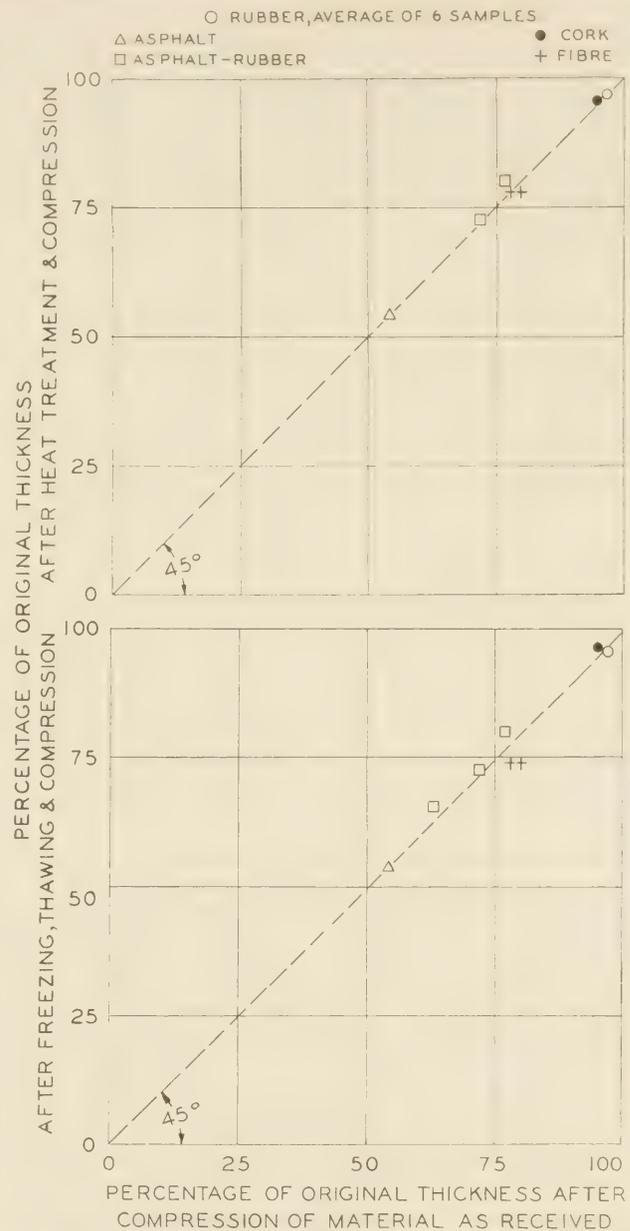
FIGURE 12.—RECOVERY AFTER COMPRESSION OF UNWEATHERED SPECIMENS COMPARED WITH RECOVERY AFTER COMPRESSION OF SAMPLES SUBJECTED TO ARTIFICIAL WEATHERING.

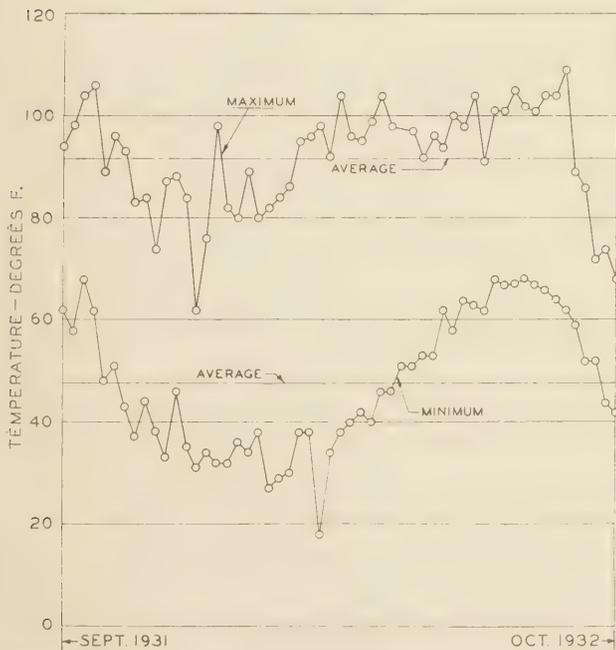
FIGURE 11.—TEMPERATURE RECORD DURING EXPOSURE TEST PERIOD.

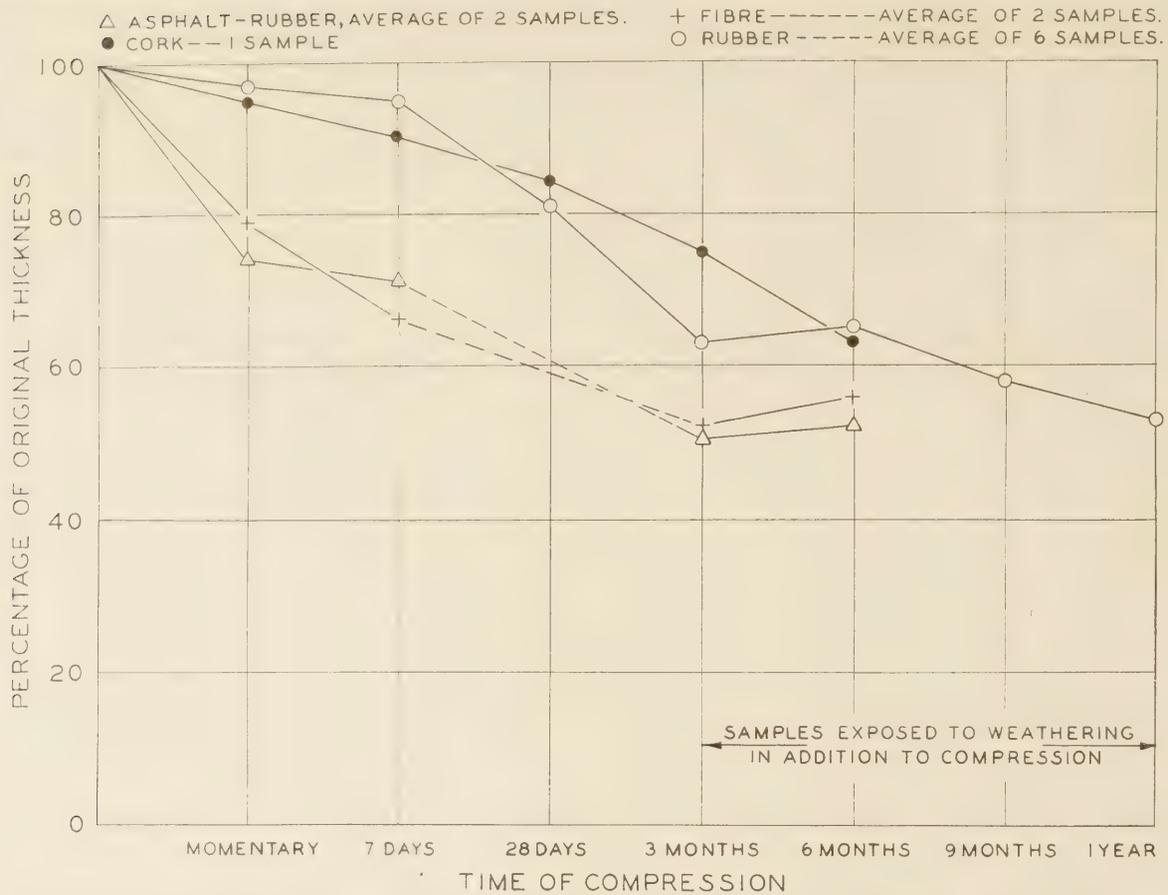
FIGURE 13.—RECOVERY OF SPECIMENS IN 24 HOURS AFTER VARIOUS TIMES OF COMPRESSION AND WEATHERING.

The recovery of specimens after sustained compression is shown in figures 13 and 14. Figure 13 shows average values for each type of material while the results for each sample of sponge-rubber filler are shown in figure 14. A recovery period of 24 hours was used in all cases. The cork filler showed a progressive loss in resiliency with increase in time of compression. After being compressed for 7 days, the cork filler recovered to 90 percent of its original thickness, but after 6 months compression a recovery to only 63 percent was found. The sponge-rubber filler showed on the average somewhat better recovery at 7 days, but at 6 months the recovery was practically the same as for the cork. After being under compression for 1 year, the sponge rubber in general had practically no recovery. Con-

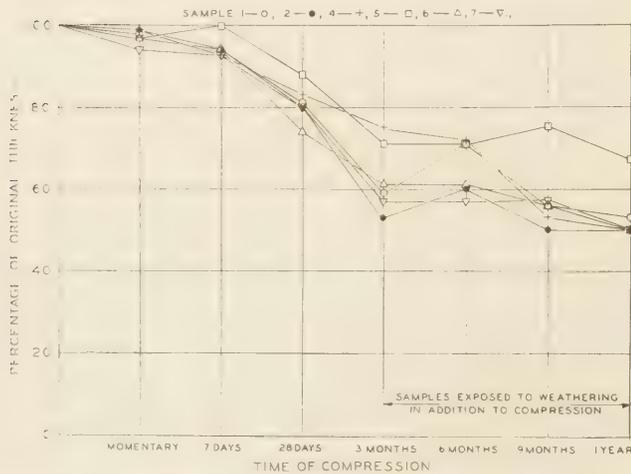
FIGURE 14.—RECOVERY OF INDIVIDUAL SPECIMENS OF SPONGE RUBBER IN 24 HOURS AFTER VARIOUS TIMES OF COMPRESSION.

consideration of the individual samples of sponge rubber indicates that one sample is somewhat superior to the others in resistance to fatigue. This sample, no. 5, showed a recovery to 67 percent after compression for 1 year. Sample 4, made by the same manufacturer, showed no recovery, and it is possible that the results for sample 5 may be somewhat in error. Four of the other samples showed no change in thickness upon release of pressure, and one recovered slightly to 53 percent of its original thickness. After compression for 28 days, all samples of sponge rubber showed recoveries of 74 percent of their original thicknesses or better. The fiber and asphalt-rubber fillers had relatively little

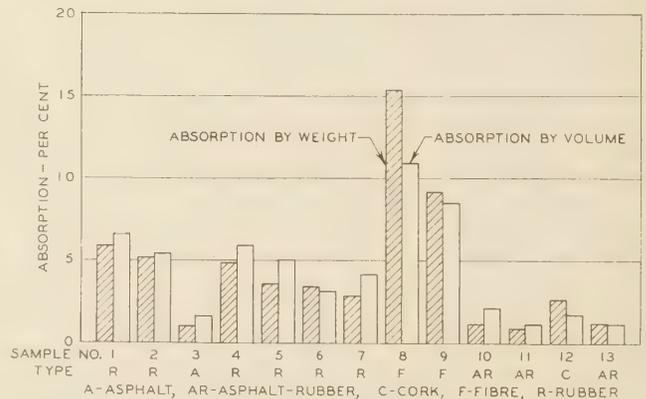
FIGURE 15.—ABSORPTION OF SPECIMENS IN 24 HOURS.
